An Assessment of Visual Testing

Pacific Northwest National Laboratory

**U.S. Nuclear Regulatory Commission
Office of Nuclear Regulatory Research
Washington, DC 20555-0001**

Manuscript Completed: November 2004
Date Published: November 2004

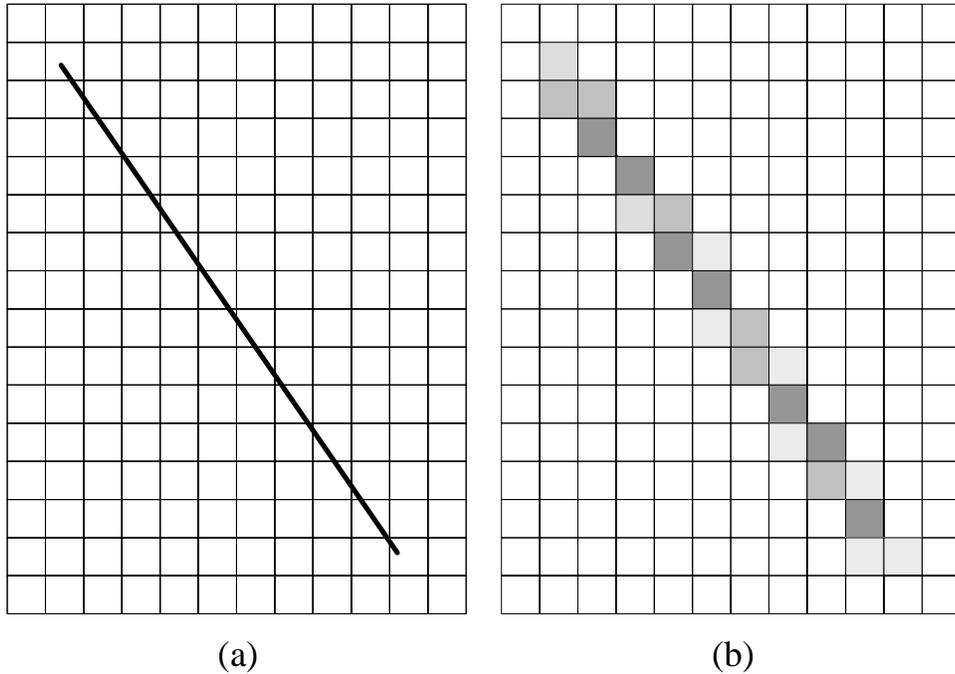
Figure 2.1 Pixelation of line (a) into lower-contrast image (b).

The maximum possible visual acuity of a video or digital system can be described by comparing the native resolution of the system to the size of the area on which the system is focused. This measure of visual acuity assumes perfect optics and a perfect electronic capture of the image. Using this method, a 1 megapixel (1200 x 800 pixels) camera that can focus on an area 75 mm x 50 mm (3 in. x 2 in.) would have a pixel size of 0.0625 mm/pixel. Any indications that fall below this size would be pixelated and recorded as a lower-contrast shadow in the larger pixel, as the contrast from the indication is averaged with the background in the pixel. The color and shading of the pixel is dependent on the contrast between the indication and the background and on the MTF of the camera. An example of a linear indication in which the width of the line is significantly less than the pixel size is shown in Figure 2.1.

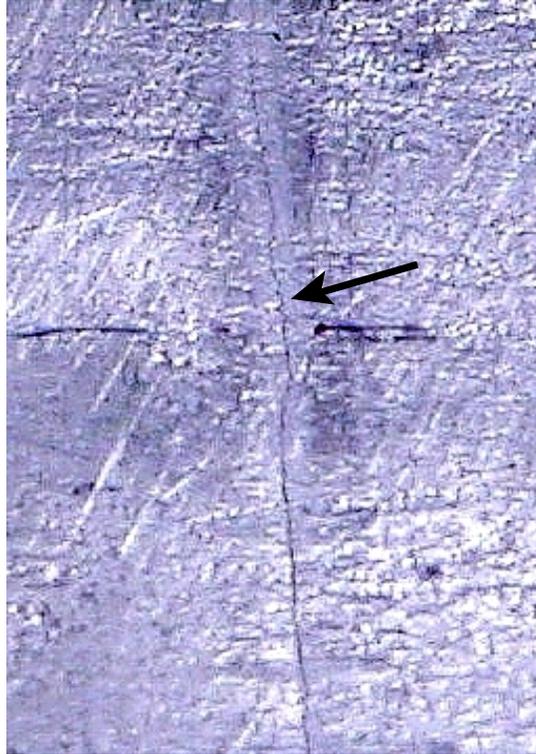
Figure 3.1 25- μm (0.001-in.) COD Mechanical Fatigue Crack in Stainless Steel

Mechanical fatigue cracks are formed when a material is subjected to repeated stress cycles. Cracks formed in this way are relatively straight and typically do not branch significantly, if at all. The COD is highly dependent on the stresses in the material. The crack is widest during the phase when the tensile stresses perpendicular to the crack face are at their highest. When the stresses that form the crack are not present, the COD shrinks considerably and may close almost entirely. Often there is not much corrosion inside the crack. A typical mechanical fatigue crack is shown in Figure 3.1.

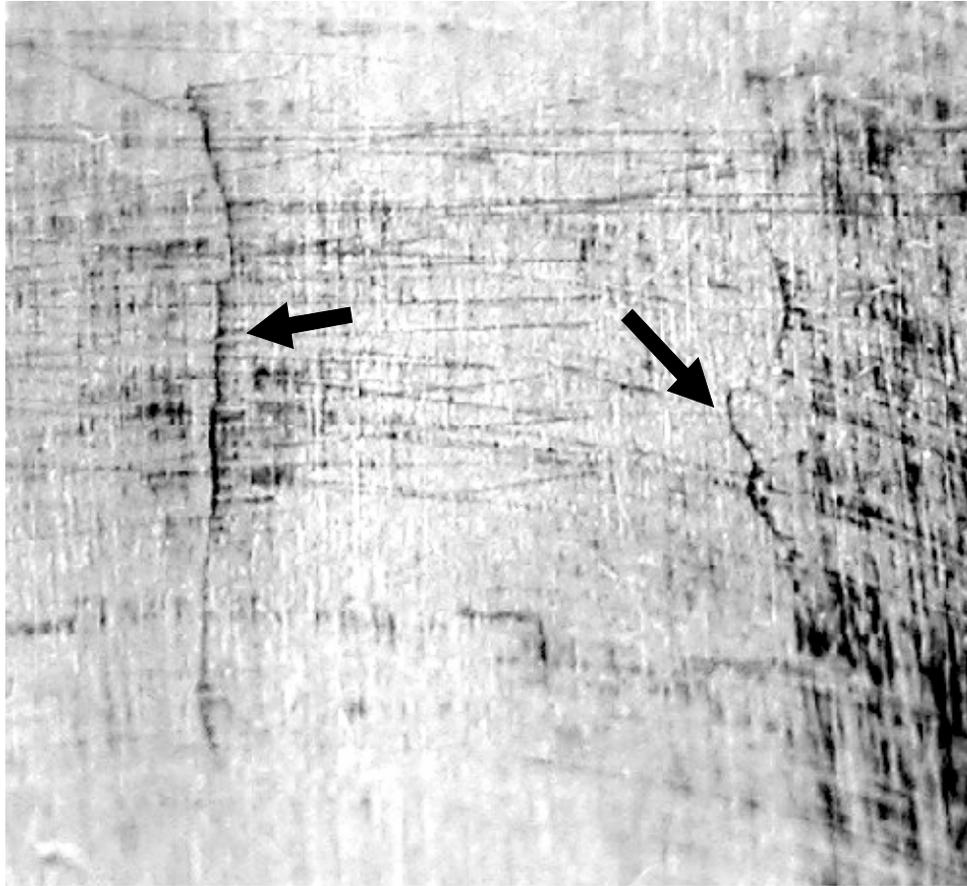
Figure 3.2 Two 15- μm (0.0005-in.) COD Thermal Fatigue Cracks on Machined Stainless Steel Surface. There is discoloration and chipping at the crack opening, increasing the visibility of the cracks. (Image converted to black and white and contrast-enhanced).

Thermal fatigue cracks can be manifested in regions of components with stratified hot and cold water levels that change with time. Thermal fatigue cracks will typically form in patterns. In a material without any predominant directional stresses, thermal fatigue cracks often form in a fabric-like or cobblestone pattern in the affected material. If the material in question is under a tensile stress, then multiple small thermal fatigue cracks often form with the cracks perpendicular to the direction of the stress. There may or may not be oxidation inside the crack, and thermal fatigue cracks can have a very small COD. The COD of a thermal fatigue crack is strongly dependent on the stresses perpendicular to the crack opening. A pair of thermal fatigue cracks that formed near one another is shown in Figure 3.2. Note the variation in linearity and the background noise due to machining operations.

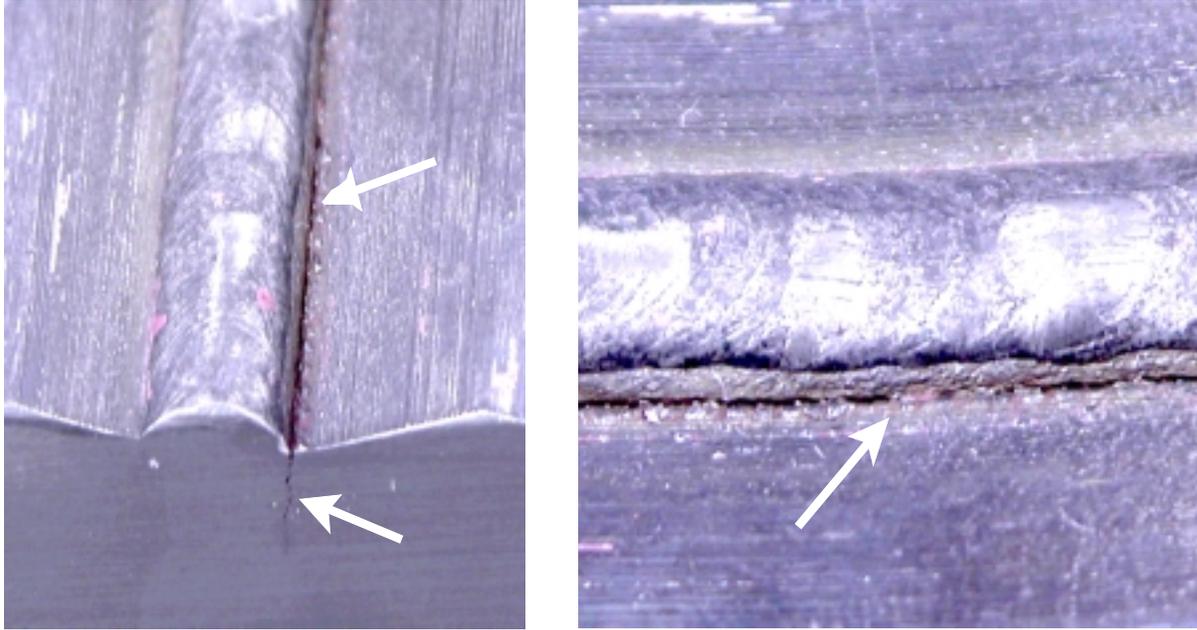
Figure 3.3 Two Views of 125- μm (0.005-in.) COD Stress Corrosion Crack along Weld in Stainless Steel.

Stress corrosion cracking (SCC) is caused by a combination of stress, a sensitized material, and a corrosive environment. In stainless steel, these cracks usually form along heat-affected zones near welds, as the welding process causes the heat-affected zone to become sensitized. These cracks vary in appearance, ranging from a single crack to a series of cracks lying together in a slightly feathered pattern but nearly always following the sensitized zone. Welds also have internal residual stresses created in the welding process, which provide the stress needed to propagate a SCC. Older SCCs may have some oxidation on their inside surfaces causing grains of material to dislodge from the crack face, widening the SCC. However many SCCs have a very small COD. An SCC following the heat-affected zone in a weld is shown in Figure 3.3. Note the liquid penetrant residue from a previous surface examination to enhance crack detection.

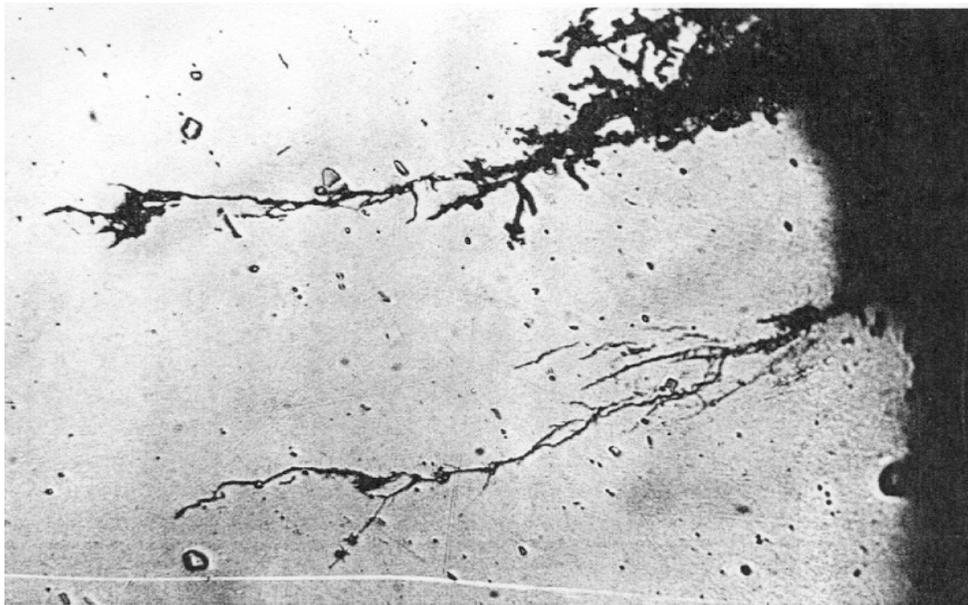
Figure 3.4 Two Stress Corrosion Cracks in Locking Bolt (100X magnification) (Morrin et al. 1978)

The factors influencing the CODs for stress corrosion cracks are more complex than for fatigue cracks. Stress corrosion cracks form because of an interaction between a sensitized material, a corrosive environment, and stress in the material. When SCC occurs, the opening size may depend on the susceptibility of the material and the residual stresses around the crack. A stress corrosion crack can have a very small COD if one grain boundary is affected in a lightly susceptible material or a very large COD in a very susceptible material when several surface grains are dislodged from the crack (Garcia et al. 2001). A highly sensitized material can form many SCCs in the same area, which may then link up and form a crack with a large COD. A less sensitized region will have fewer and tighter SCCs. There is no reliable way to gage the depth of an SCC based on its COD. Examples of SCCs with small and large CODs are shown in Figure 3.4. It is worth noting that both cracks have penetrated to essentially the same depth.

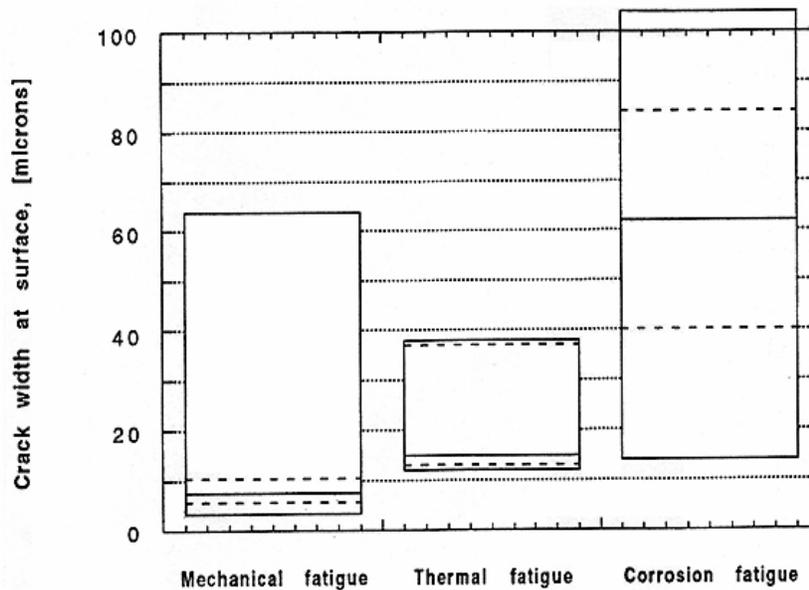
Figure 3.5 Crack Opening Dimension Distribution for Fatigue Cracks (Ekström and Wåle 1995)

Figures 3.5 and 3.6 contain charts that show a compilation of work done by several groups who have characterized the CODs of fatigue cracks and SCCs. The middle line in each bar represents the median crack size, and the upper and lower dashed lines represent the sizes of the 75% and 25% limits. Figures 3.7 and 3.8 show the distributions of CODs to crack through-wall depth.

Figures 3.5 and 3.6 show that cracks in reactor components have a wide distribution of CODs with a significant number of cracks having a COD below $12 \mu\text{m}$ (0.0005 in.). Figures 3.7 and 3.8 further reinforce the premise that there is a weak relationship between the COD of a crack and its through-wall penetration.

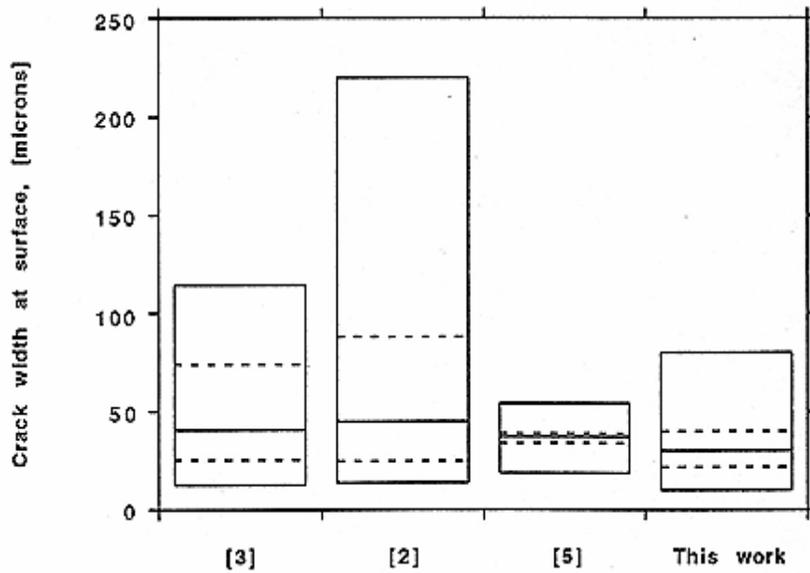
Figure 3.6 Crack Opening Dimension Distribution for Stress Corrosion Cracks. Study 3 was conducted by MacDonald, 2 by Lapides, 5 by Stenefjall, and “This work” refers to the work of Ekström and Wåle (1995).

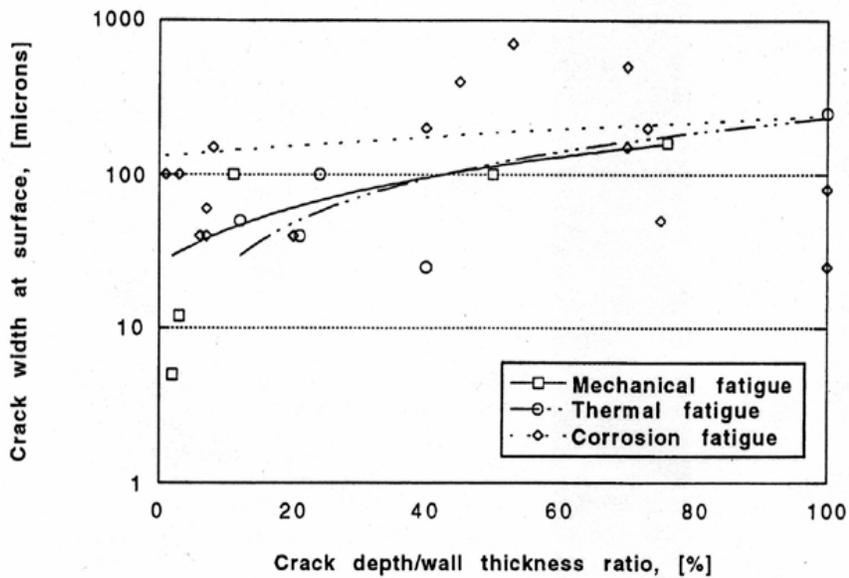
Figure 3.7 Crack Opening Dimension Versus Crack Depth for Fatigue Cracks in Ferritic Steel (Ekström and Wåle 1995)

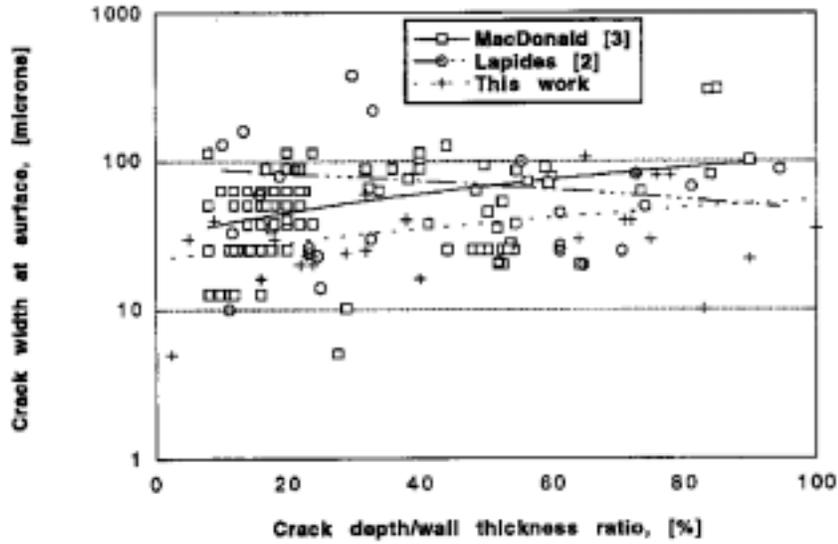
Figure 3.8 Crack Opening Dimension Versus Crack Depth for IGSCCs in Austenitic Stainless Steel (Ekström and Wåle 1995)

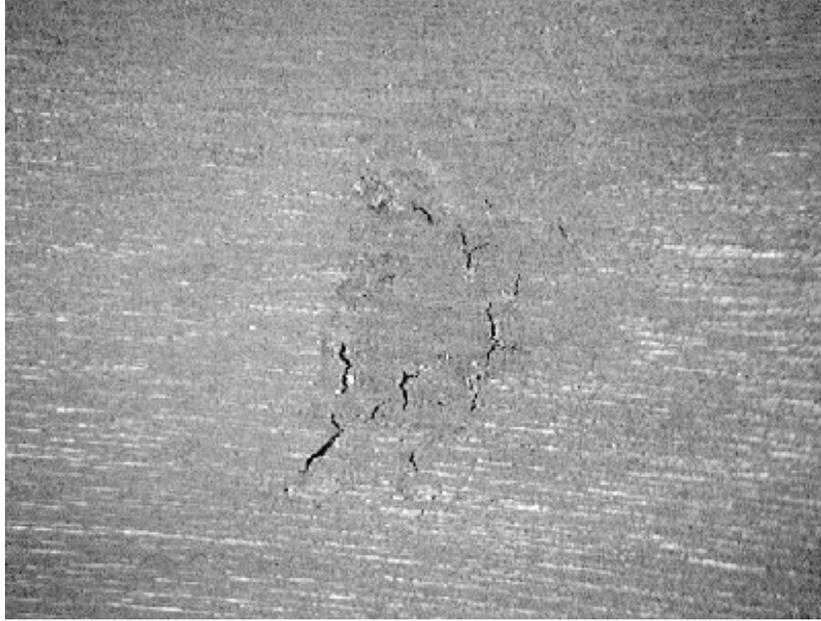
Figure 4.1 Cracking in Reactor Pressure Vessel Cladding as Imaged by a DIAKONT Closed Circuit Video System (Vasiliev et al. 1999)

The results of a remote visual examination on the interior of the Russian Kalininskaja VVER reactor pressure vessel using a DIAKONT reactor TV inspection system are shown in Figure 4.1 (Vasilev V. G. et al 1999). The cracks are in the cladding of the pressure vessel and have CODs of between 50 to 200 μm (0.002 to 0.008 in).

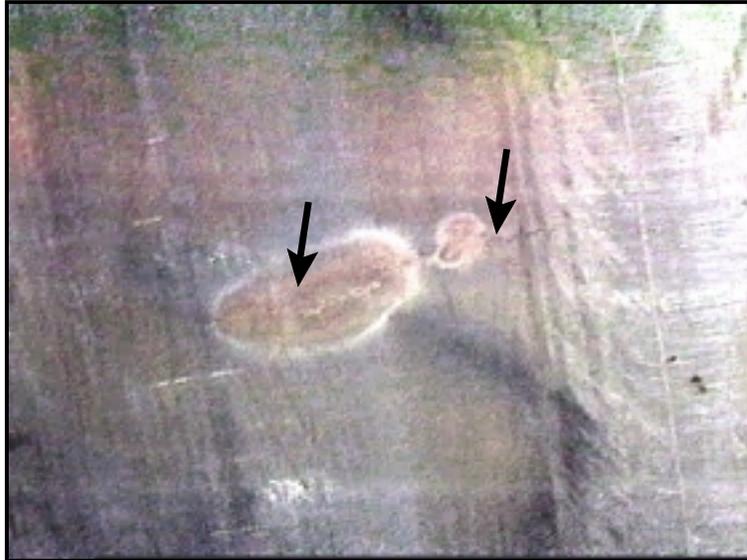
Figure 4.2 Axial PWSCC Crack in V.C. Summer Nuclear Station Pressure Vessel Nozzle to Pipe Weld. The COD of the crack is not known.

One crack imaged using VT was a through-wall axial crack in the piping of V.C. Summer Nuclear Station. The crack was detected by indirect means; specifically, boric acid deposited from primary coolant leaking through the pipe was the first indication of a crack. The pipe was visually examined twice. The first examination used a video camera on the end of a long pole; the second used a robotic scanner. The first VT test missed the crack, while the second, performed by WesDyne, successfully detected the crack. The contrast and size of the crack image was enhanced as there was corrosion of the ferritic steel of the pressure vessel nozzle forging which bled back through the crack, lining it with reddish corrosion products. The crack is shown in Figure 4.2.

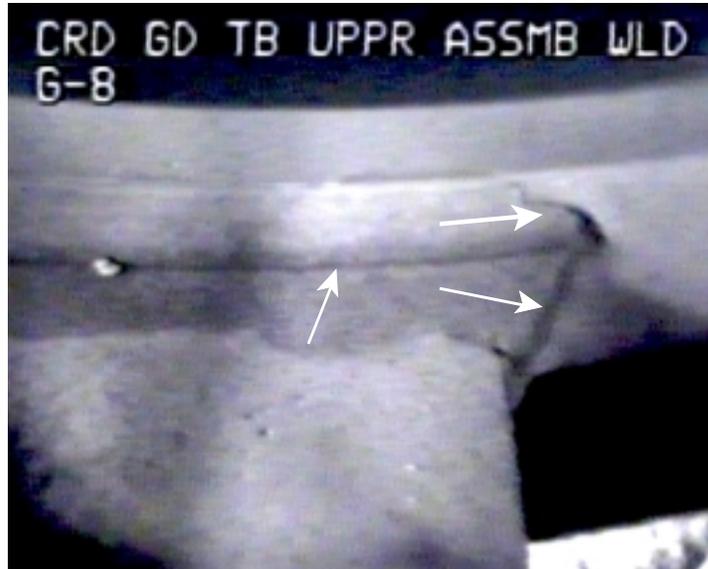
Figure 4.3 Crud lines on the surface of the piece strongly resemble cracks and can hide real indications.

An examination of the videotaped images shows that the level and method of cleaning of the component can strongly influence the results. While it has been previously noted that any extraneous material on the surface of a component being examined with VT may mask a relevant feature on the surface, improper cleaning can result in crud lines (streaks of dirt left over from cleaning) and rub marks that can also look like cracks. The part or region to be examined needs to be cleaned of all dirt and crud while not leaving the remnants of the cleaning process. An example of a component with observable crud lines is shown in Figure 4.3.

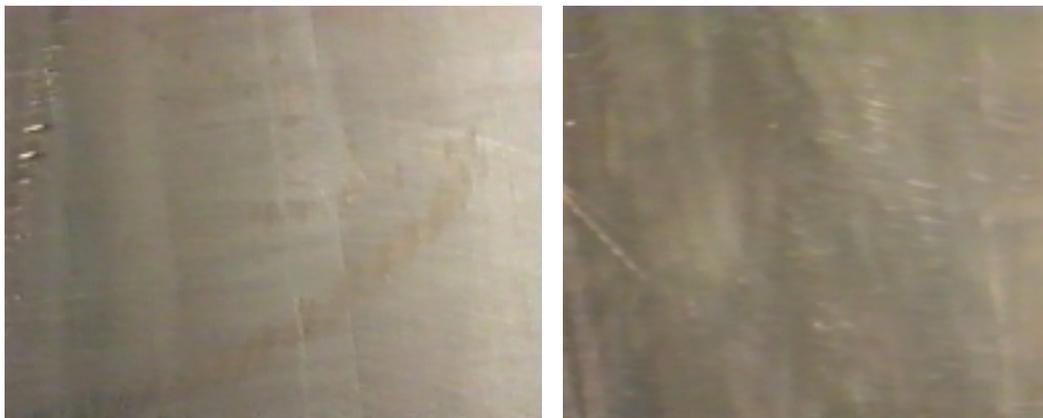
Figure 4.4 Reduction of Visual Acuity During Scanning. Left: a screen capture from when the camera is not moving. The vertical lines are sharp and the picture is relatively clear. Right: a screen capture of different area when the camera is moving. The vertical lines are blurred, as is the rest of the picture.

An example of the loss of visual acuity when a camera is scanning is shown in Figure 4.4. The picture is significantly sharper when the camera is stationary (system normal visual acuity) over a zone as opposed to scanning (system kinetic visual acuity). This lower kinetic visual acuity demonstrates that a system capable of passing a resolution test when not moving can possibly fail when the camera is being scanned.

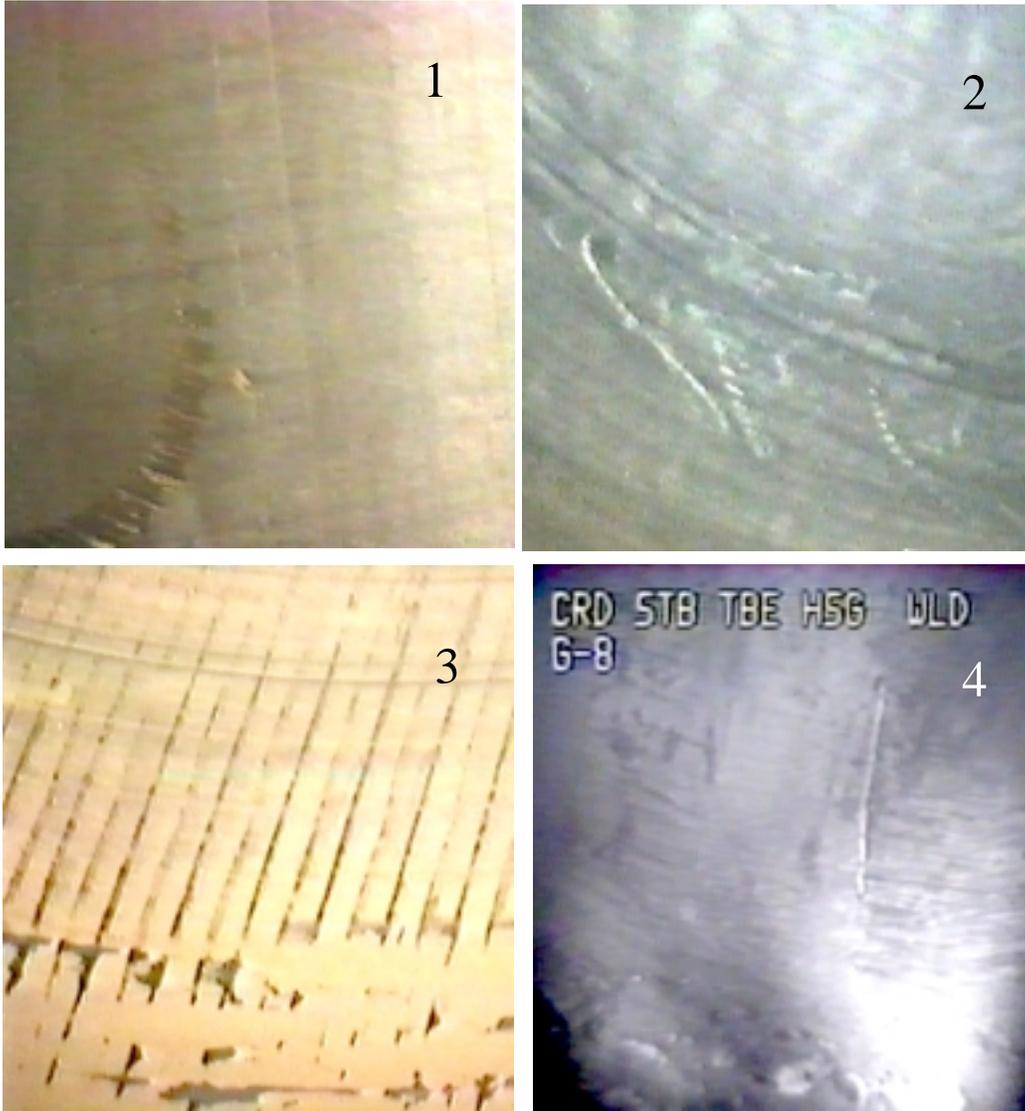
Figure 4.5 Four Images from Visual Inspections of Pressure Vessels and Piping. 1. Close-up of the metal near a weld showing scratches and markings. 2. Close-up of a pipe interior showing scratches and marks. 3. Manufacturing axial and circumferential markings on the interior of a PWR pipe. 4. Scratches and a vertical rubbing mark on a control-rod drive stub tube housing.

U.S. reactor pressure vessels (RPVs). The interiors of the RPVs have machining and grinding marks over most surfaces. Some areas are discolored and possibly slightly oxidized. These scratches and machining marks provide a lot of visual “noise” that may mask cracking. Four examples of the interior conditions of pressure vessel internals and piping are shown in Figure 4.5.

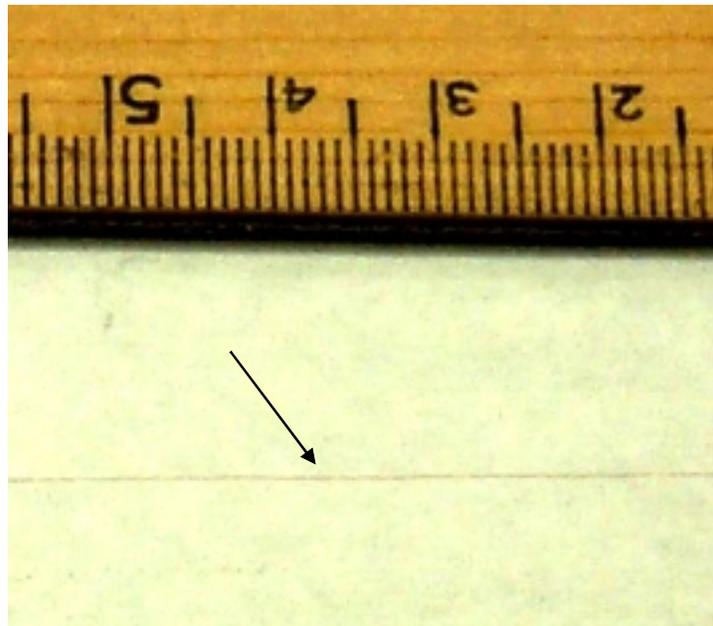
Figure 4.6 Resolution Demonstration with 25- μm (0.001-in.) Diameter Wire Image Taken using 1-megapixel Camera

Figure 4.6 shows that a 1-megapixel, 3X zoom digital camera used to study crack openings can easily image a 25- μm (0.001-in.) Diameter wire. Photographs of selected cracks are shown in Figures 4.7 through 4.9. These photos were taken under laboratory conditions, using a tripod and careful lighting. Figure 4.7 shows a thermal fatigue crack with a COD of 12 μm (0.0005 in.). This thermal fatigue crack is not difficult to image, as it has some discoloration around the crack opening that has turned black and contrasts strongly with the steel. This crack has propagated 50% through-wall. Figure 4.8 shows a thermal fatigue crack that also has a COD of 12 μm (0.0005 in.). The material has been sanded down to a smooth surface, making the crack difficult to detect from most angles. It is also difficult to photograph clearly, as the crack is shown as a barely perceptible line. This crack also has a 50% through-wall depth. Figure 4.9 shows an 80% through-wall mechanical fatigue crack with a COD of 125 μm (0.005 in.) and a 50% through-wall mechanical fatigue crack with a COD of 25 μm (0.001 in.) on a smooth surface. The 80% through-wall crack is very easy to detect from nearly any angle. The 50% crack can be seen only on close inspection. As some of the cracks are on the edge of the camera detection ability, printouts and photocopies of these pages may not show all of the details even though the contrast had been digitally enhanced

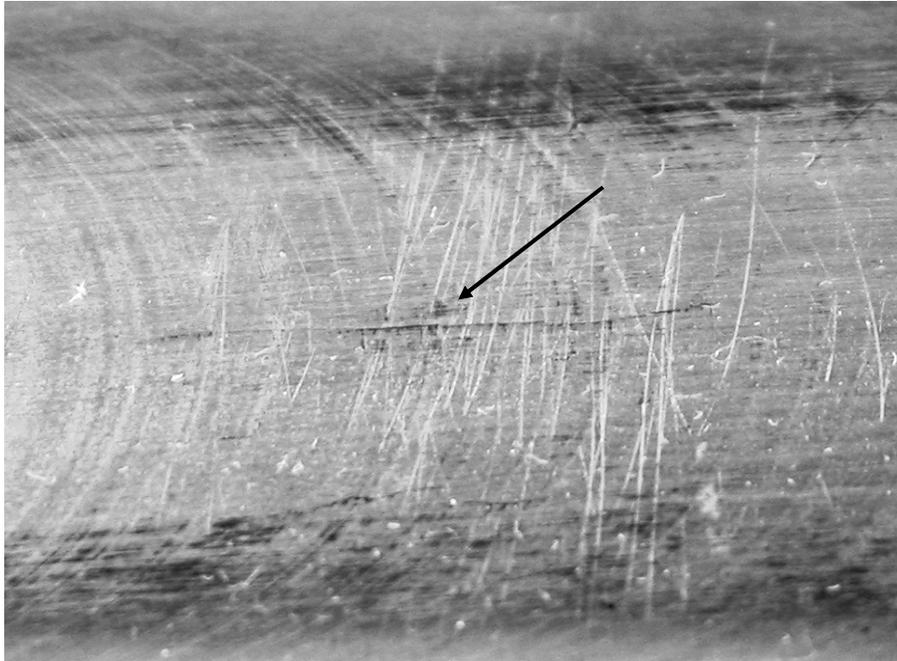
Figure 4.7 12- μm (0.0005-in) COD Thermal Fatigue Crack on Machined Surface. The crack is clearly visible despite its small COD, as there is discoloration around the crack opening

The photography of the cracks demonstrates that a digital camera able to detect a 25- μm (0.001-in.) wire may not be able to resolve similarly-sized cracks. In several cases a very close visual inspection could find cracks that were invisible to the digital camera. During the direct visual inspections we were able to examine the specimens at a much shorter distance than with the digital camera, allowing for better detection.

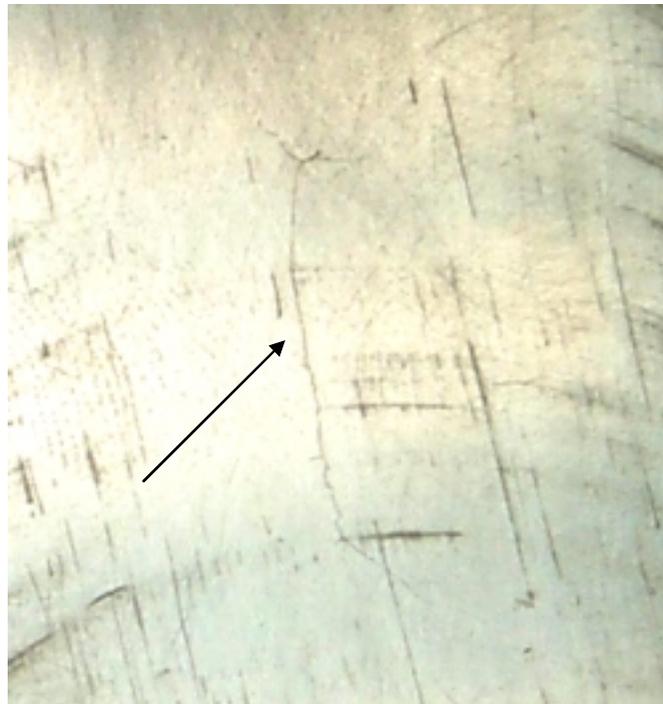
Figure 4.8 12- μm (0.0005-in.) Thermal Fatigue Crack on Smooth Surface

Figure A.3 Sample B118 Showing difficulty in Detecting a Thermal Fatigue Crack. With higher magnification, the crack is detectable, as shown in Figure 4.8

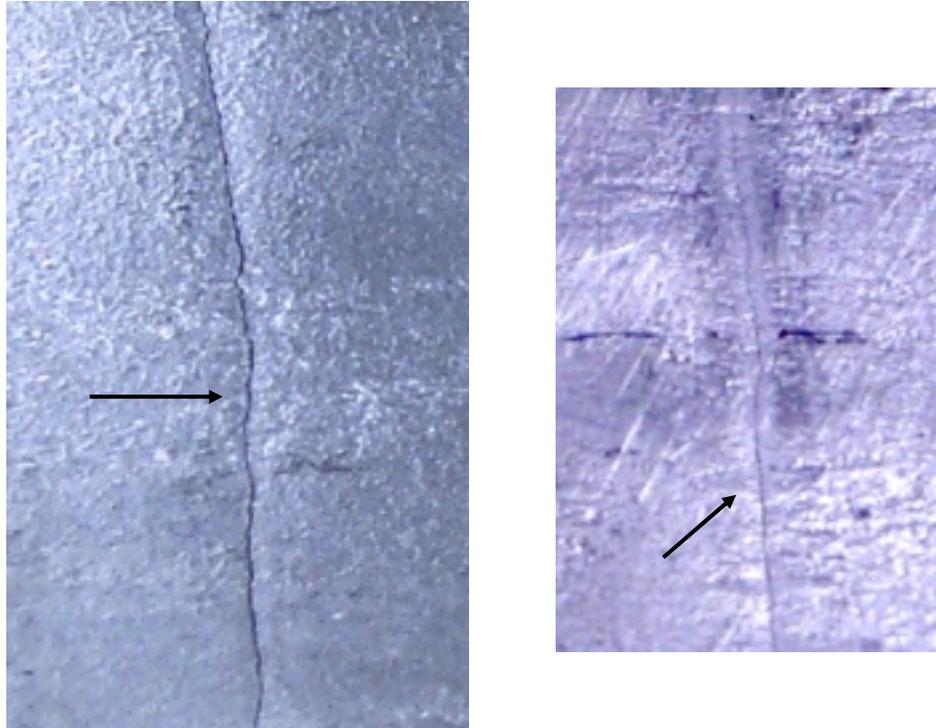
Figure 4.9 125- μm (0.005-in) COD and a 25- μm (0.001-in.) COD Mechanical Fatigue Crack on Smooth Surfaces. The 125- μm COD crack is clearly visible, while the 25- μm COD crack is visible only on close inspection.

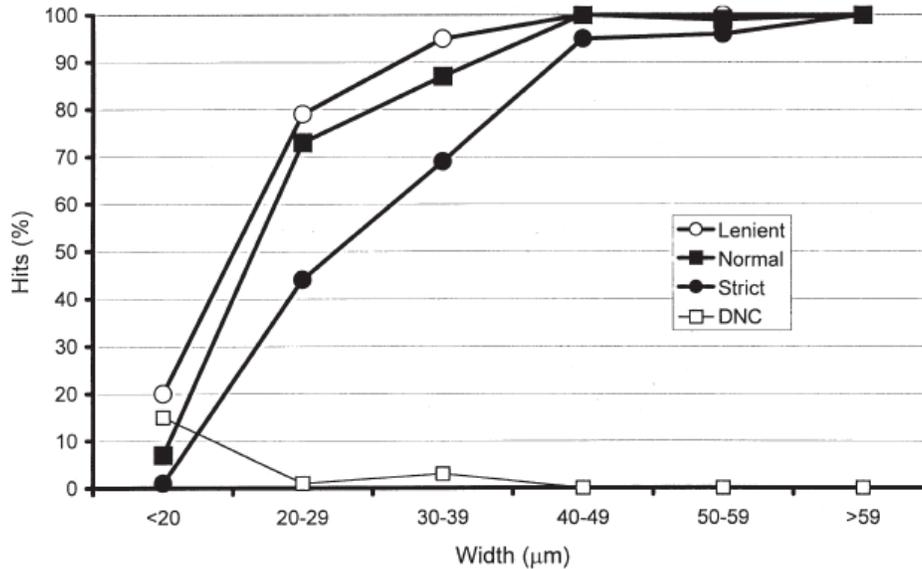
Figure 4.10 Crack Detectability Versus Crack Opening Dimension (Enkvist J. 2002)

counted all but DNCs as hits. The results are shown in Figure 4.10. Cracks above 40 μm COD were easily detected, while cracks below 20 μm COD had, at best, a 20% probability of detection using the “Lenient” grading scale.

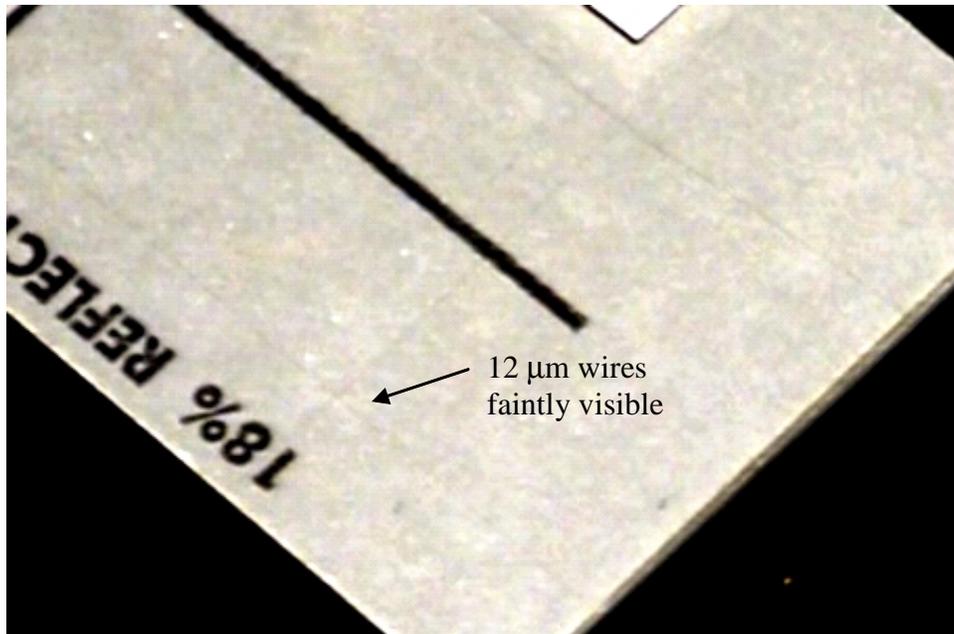
Figure 5.1 Example of Current Performance Demonstration Standard Showing two 12 μm (0.0005 in.) Crossed Wires Against an 18% Neutral Grey Card

An example of a camera system using a 12- μm (0.0005-in.) wire detection test is shown in Figure 5.1. It should be noted that the resolution target also contained a series of letters for use as a reading chart. For ease of viewing and printing, contrast in the Figure 5.1 has been digitally enhanced. The wires are detectable as low-contrast fuzzy linear indications against the 18% neutral grey card. The video camera used in this example has a pixel size of 7.5 pixels/mm (190 pixels/in.) or 125 μm (0.005 in.), this being measured in a different frame which included an image of a ruler. The 12- μm wire is one tenth of the width of each of the pixels and is well below the resolution of the system at this magnification. Had the contrast between the wire and the background been weaker, or if any visual noise were near the wires, the wires would probably not be detectable.

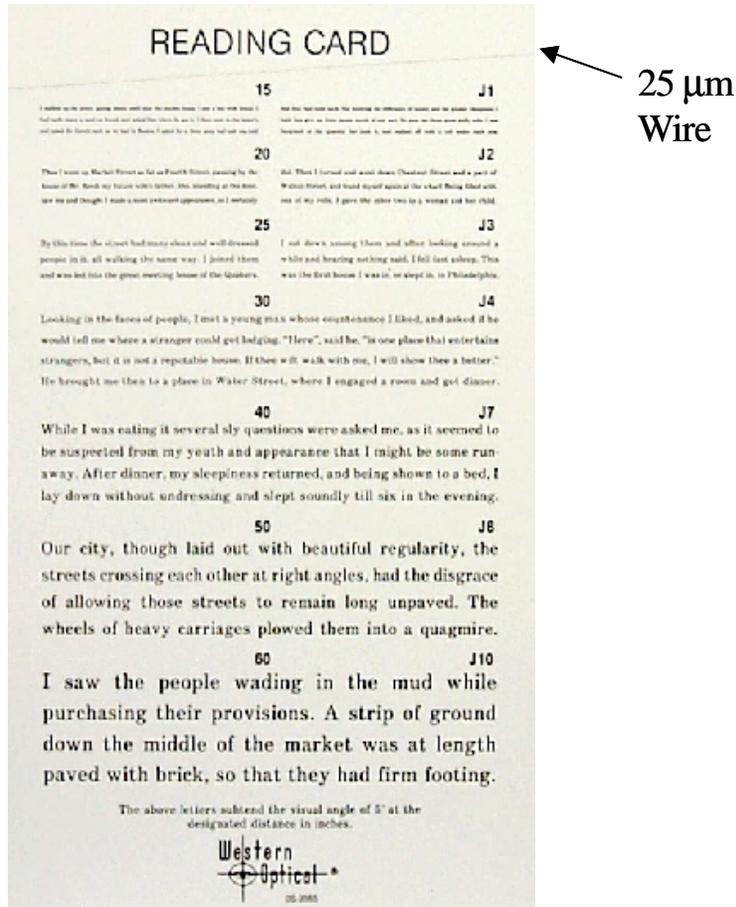
Figure 5.2 Jaeger Reading Chart with 25 μm (0.001 in.) Diameter Wire Stretched Below the Card Title.

Simple line detection using thin wires also fails when trying to characterize the readable minimum (recognition capability) acuity of a system. As shown in Figure 5.2, a 25 μm (0.001 in.) diameter wire is visible as a low-contrast line against a white Jeager reading card while the

smallest writing that is easily readable on the card corresponds to 20/60 vision. An intentionally out-of-focus photograph of the same chart is presented in Appendix A.

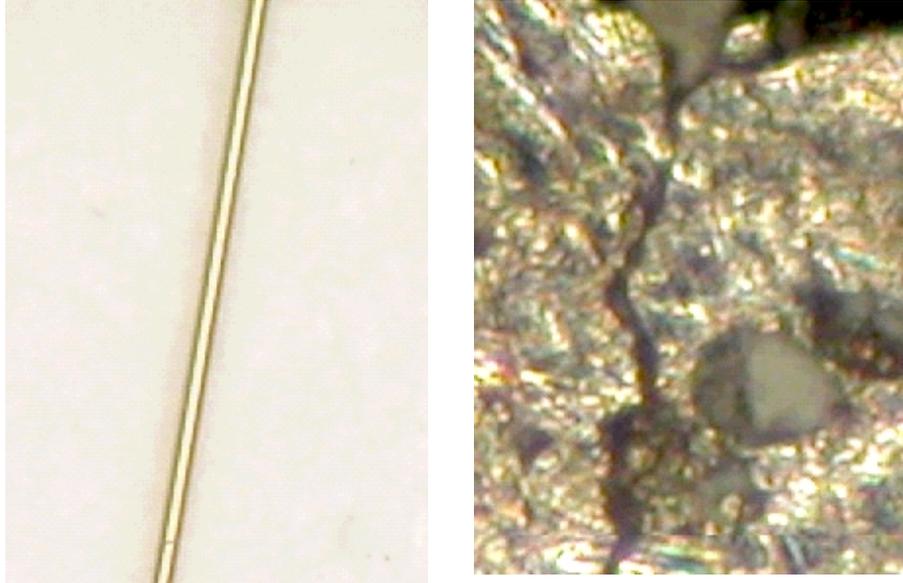
Figure 5.3 Micrographs of 25- μm (0.001 in.) Wire and Crack with a 25 μm (0.001 in.) COD

In addition to the issues related to testing the camera resolution, the wire standard is also problematic on the issue of illumination angle. There are important differences between visually detecting a stretched wire and detecting a crack. A wire sitting on the surface of a piece has a very different geometry than does an inset crack, and a wire has a very different response to light than does a crack. Lighting angles that make a wire very visible may not be effective for crack detection. One difference between a wire and a crack is that a round wire surface is very good at reflecting light, while cracks do not produce strong reflections and often are detectable only as a dark line. Another issue is that a wire will cast a relatively long shadow when a light source is placed near the surface of the piece, while a crack can never look larger than it actually is, based on shadowing effects. Figures 5.3 through 5.5 show the differences between cracks and wires. Figure 5.3 shows the different appearance of a wire and crack of the same width. Figure 5.4 is a

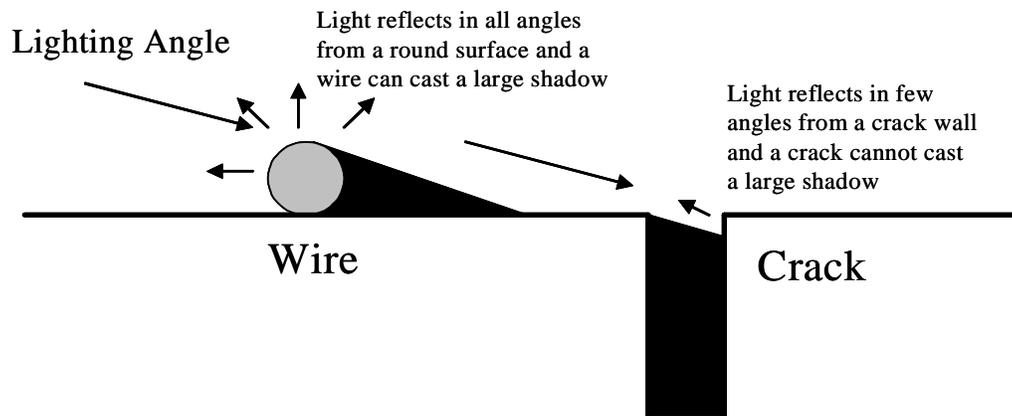
Figure 5.4 Differences in Appearances of Cracks and Wires when Lighted from the Side

schematic demonstrating how wires and cracks differ with side lighting. Figure 5.5 shows a 25- μm (0.001-in.) wire next to a 125- μm (0.005-in.) crack when lighted from the side and when lighted directly.

As Figure 5.5 shows, the side-lighted wire shows up much better than does the much larger crack. This effect is caused by a combination of the effects shown in Figure 5.4. Also interesting is that the crack also appears bright in places and dark in others, as the light is reflecting from some of the facets in the crack. When the specimen lighting is directly overhead, the crack and wire appear as dark lines, with the crack correctly appearing to be larger than the wire. As with the performance standard, a more representative standard for determining the optimum lighting could be a block with an EDM notch or crack with an appropriate width. The use of a notch or crack to arrange the lighting would provide far more accurate feedback as to which lighting setup is best for finding a crack.

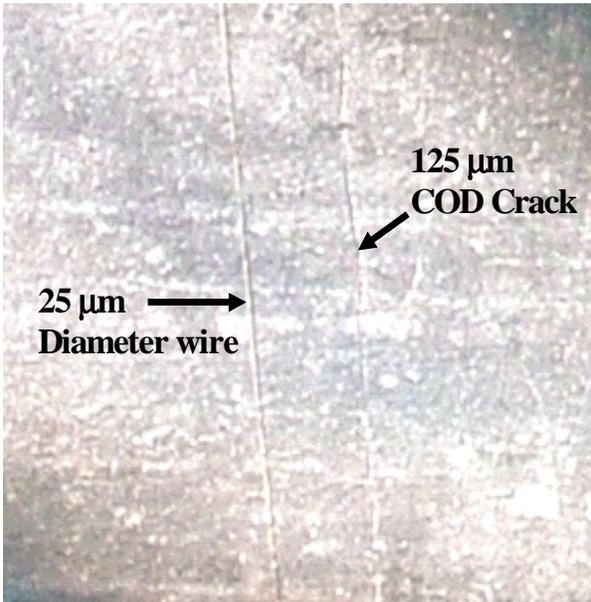
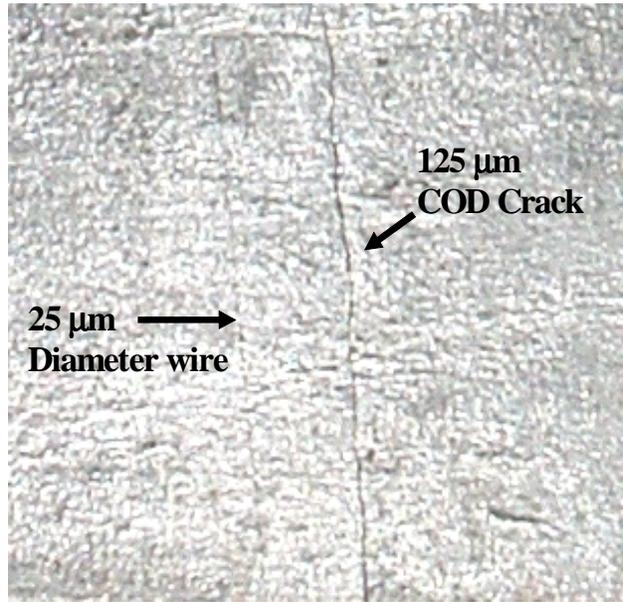
Side Lighting

Direct Lighting

Figure 5.5 Effects of Lighting Angle on 25- μm Wire and 125- μm Mechanical Fatigue Crack

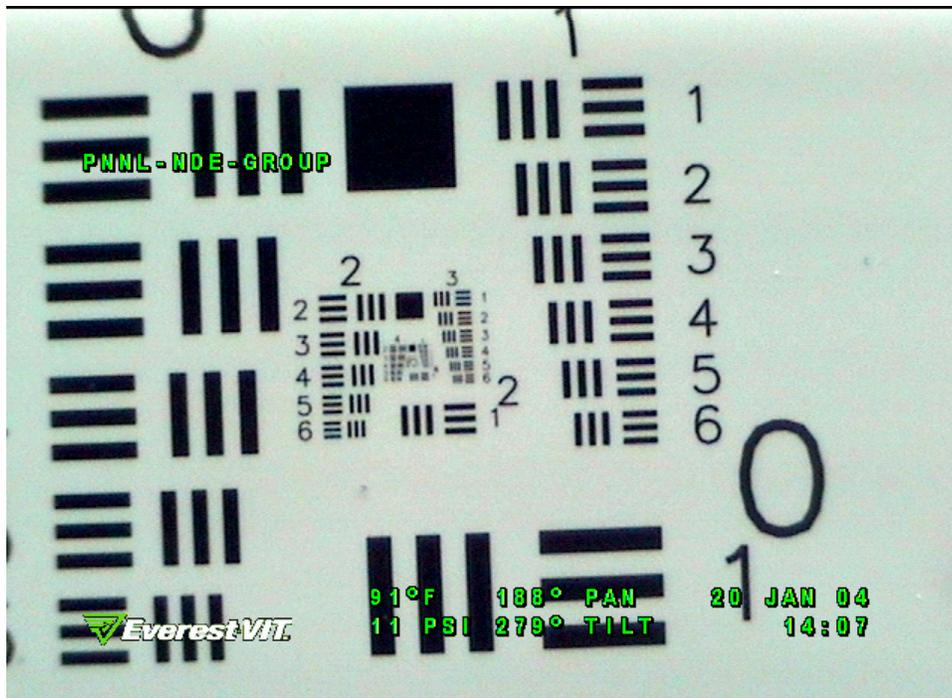
Figure 5.6 1951 USAF Resolution Target Imaged by CaZoom PTZ System

An example of a resolution test is shown in Figure 5.6. This resolution test was conducted using a 1951 USAF Resolving Power Target. The highest resolution was measured under laboratory conditions in air at approximately 4 cm (1.6 in.) from the resolution target. Using this target, researchers determined the system resolution to be 11.31 line pairs per millimeter, meaning that the system could discern a gap as small as $44\ \mu\text{m}$ (0.0017 in.) between two black lines. The inspected area was 2 cm x 1.5 cm (0.78 in. x 0.59 in.) indicating there were 32 pixels/mm (812 pixels/in.) for a pixel size of $33\ \mu\text{m}$ (0.0013 in.). If this test had been performed in water (correcting for the refractive index of water as compared to air) the pixel size would have been $25\ \mu\text{m}$ (0.001 mil).

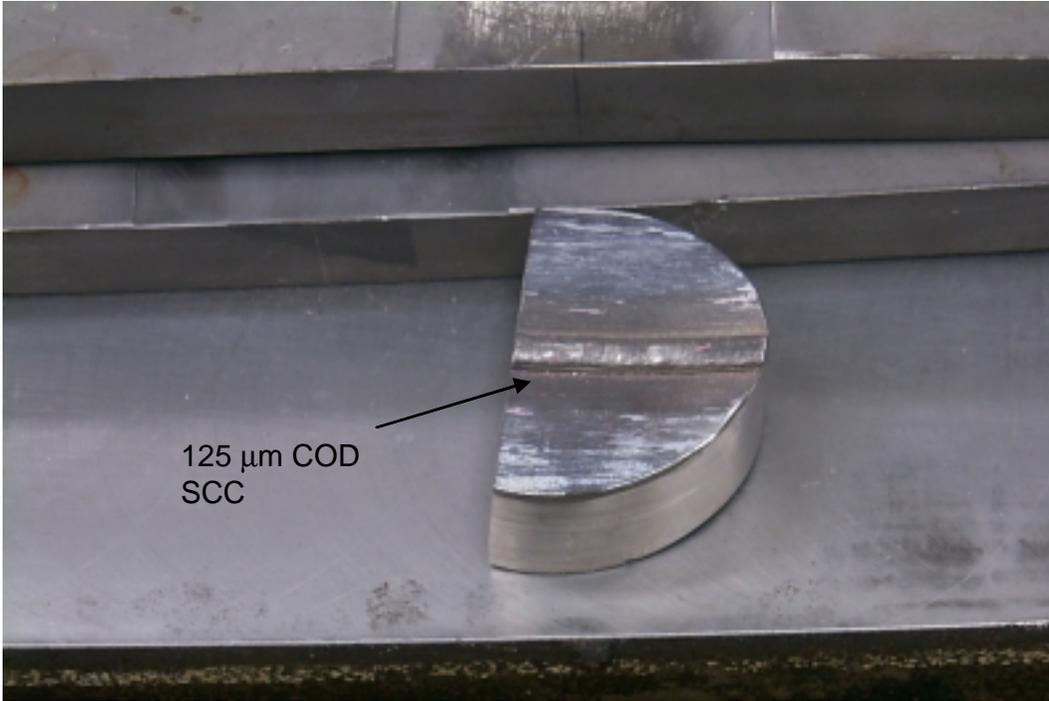
Figure A.1 Sample d32a with a 125- μm COD Stress Corrosion Crack Along the Weld Root.

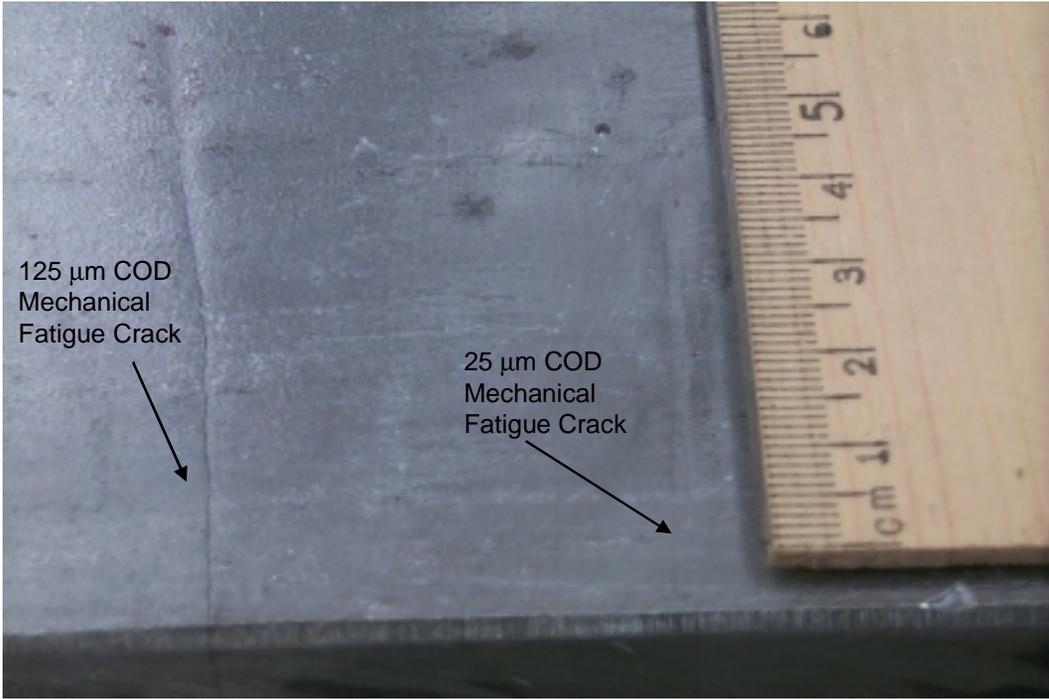
Figure A2 Two Mechanical Fatigue Cracks in Sample 4

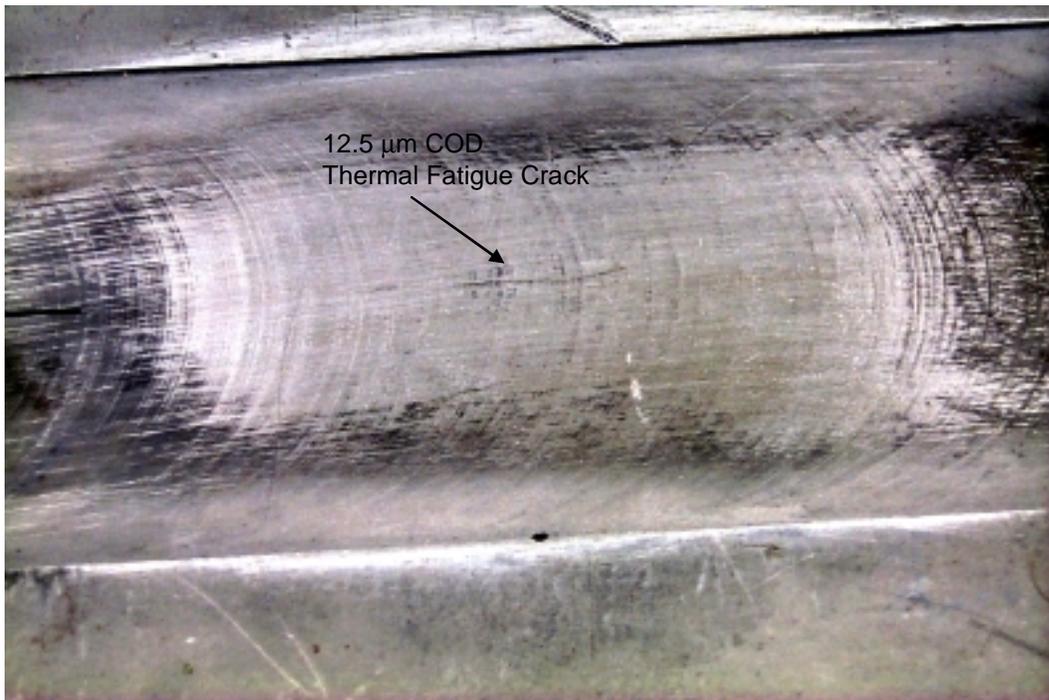
Figure A.4 Sample B117 Showing a 12- μm COD Thermal Fatigue Crack. This crack has a much higher contrast than the crack in sample B118, as the edge of the crack is chipped and discolored.

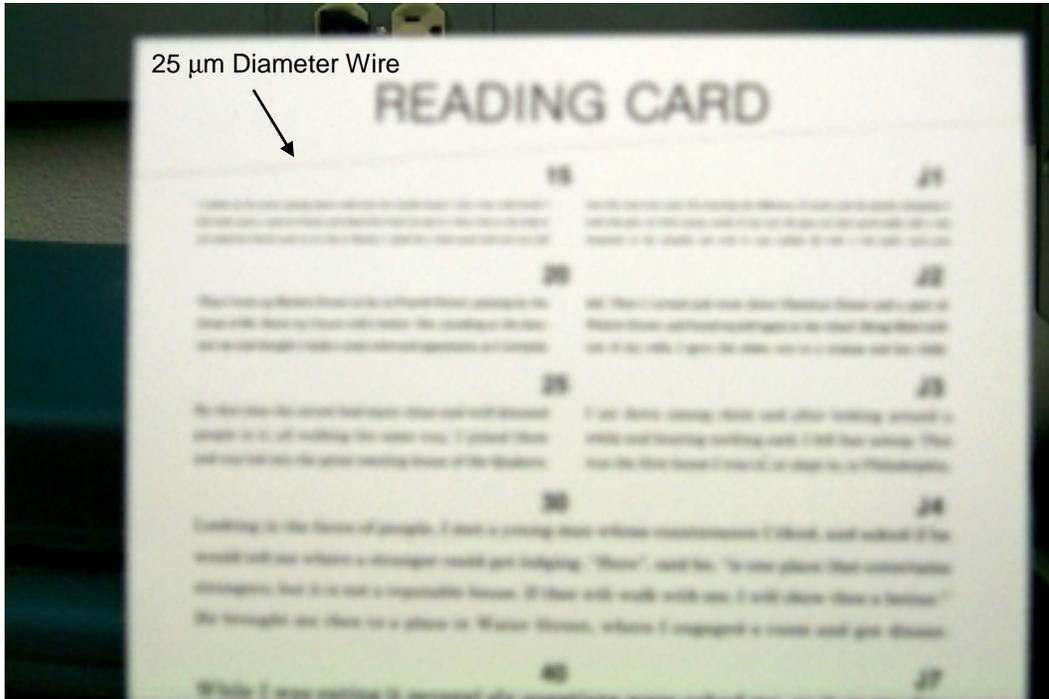
Figure A.5 Out-of-focus photo demonstrates that line detection is possible even with a very poorly functioning system.
